Operation TEAPOT

Project 5.1

DESTRUCTIVE LOADS ON AIRCRAFT
IN FLIGHT

Issuance Date: January 31, 1958

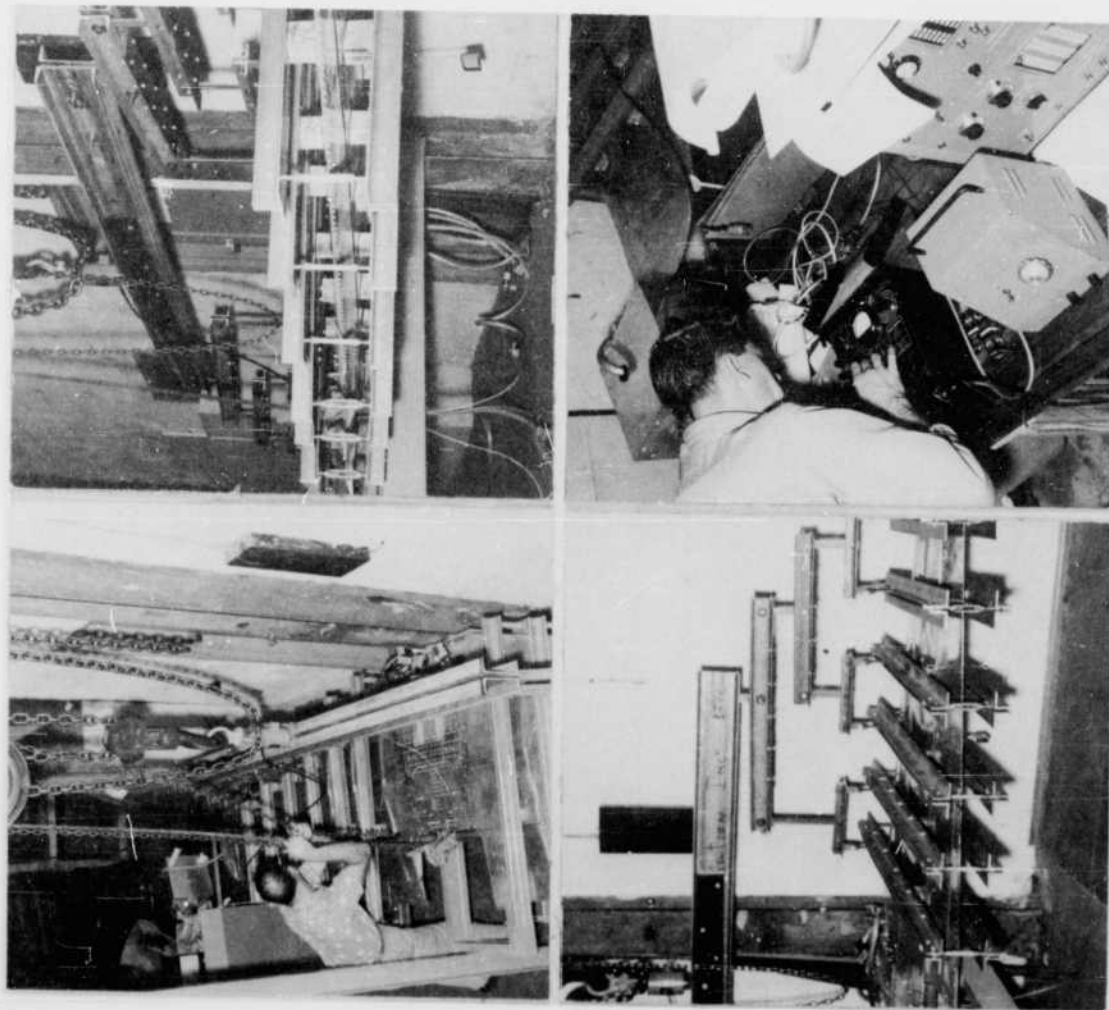
For calibrating with the large loads required on the horizontal stabilizer, it was necessary to remove the stabilizer from the airplane and install it in a special calibration fixture rigidly attached to the ground. The stabilizer is shown mounted for calibration in Figure 3.6. The load was applied in increments of 500 lb, one-half to each semi-span, up to a maximum of 6,000 lb. This resulted in a bending moment about 45 percent of limit. Calibration of one stabilizer was extended to a total load of 10,000 lb, or about 75 percent of limit load, with no

Figure 3.6 Horizontal Stabilizer Calibration. Upper Left, Applying Load; Upper Right, Deflection; Lower Left, Skin Wrinkles; Lower Right, Reading Strain Indicator.

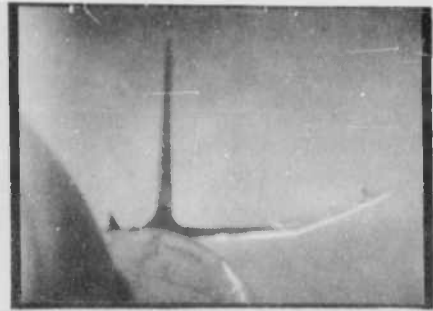
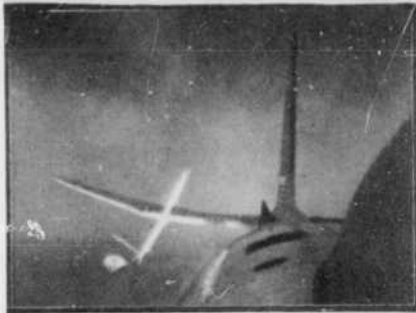
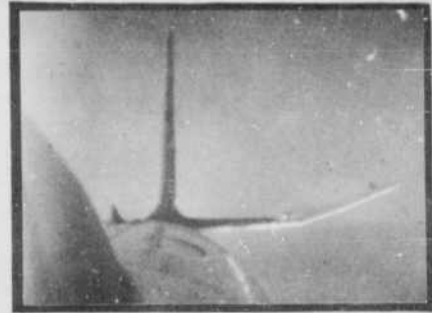
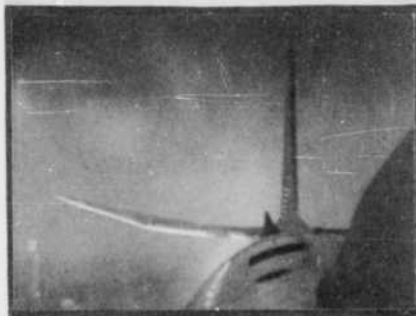
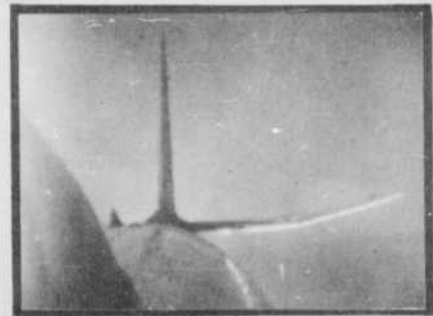
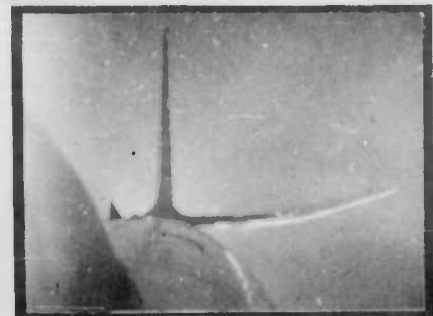
Figure 6.5 Horizontal Stabilizer Deflection at Shock Arrival, Drone 3. Numbers represent seconds after time zero.

An interesting photograph is shown in Figure 6.5, Sheet 1, at 2.07 seconds on the right side of the page. In this picture the camera caught two images of the left side of the horizontal stabilizer, one just before failure was reached and the other just after. Since the exposure time of

this frame is less than 0.008 second, the picture clearly shows the rapidity of stabilizer movement and the wide range of position covered by a single frame.

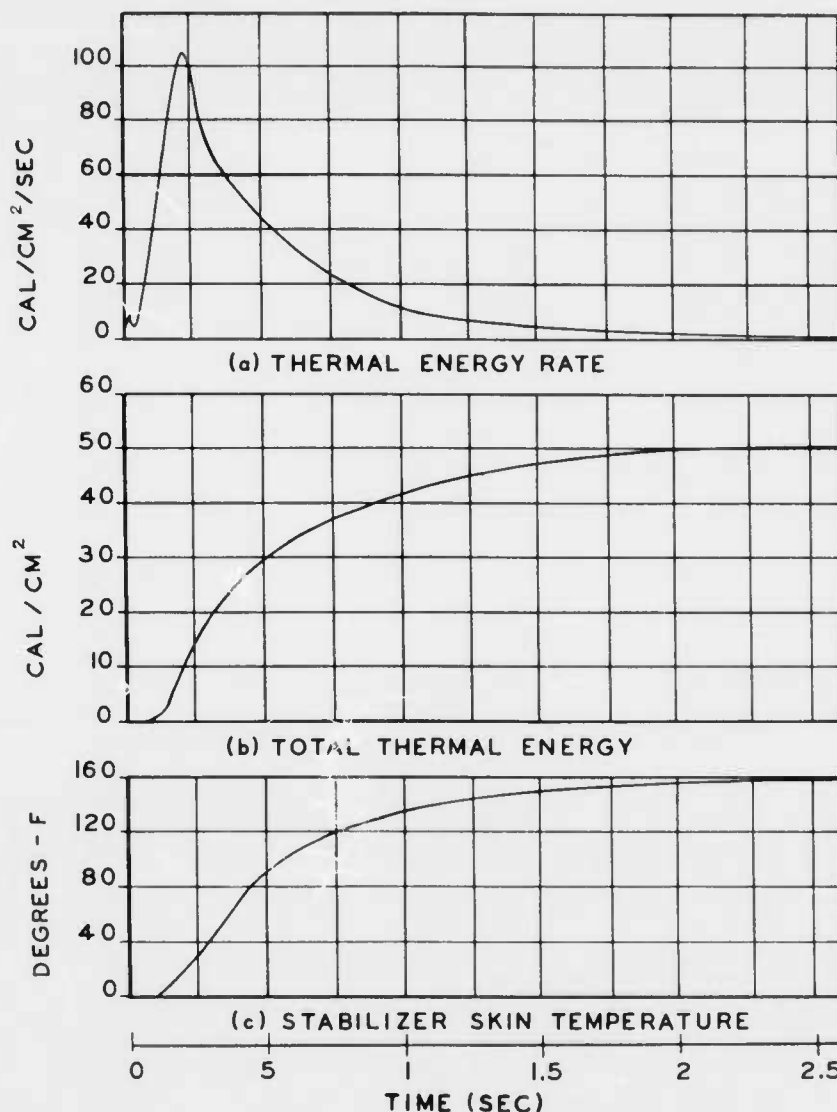
Figure 6.11 Thermal Curves, Drone 2

* This is not maximum value for Drones 2 and 3, since thermal energy was still increasing when the record was lost at shock arrival. See Figures 6.11 and 6.12.
